Stress Corrosion Behavior of Clad 7050-T76 Aluminum Sheet

B. T. Sanderson and W. F. Gerhold

April 1978

**Prepared for
Naval Air Systems Command
Department of the Navy
Washington, D.C. 20360**

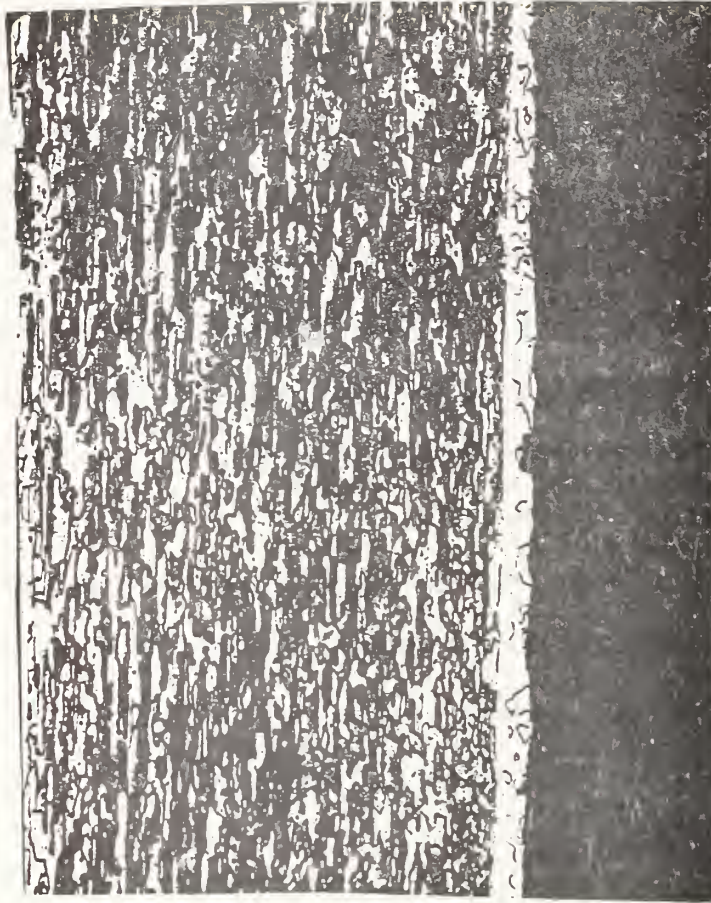
Figure 1. Photomicrograph of clad 7050-T76 aluminum alloy showing localized pitting corrosion in the cladding material and typical microstructure. Etched, Kellers Etch. X50.

Transverse sections were obtained from the exposed samples for metallographic examination (Fig. 1). The localized corrosion pitting is visible in the cladding material. In general, the microstructure revealed a uniform grain size in both the clad and core material.
